DEPARTMENT OF TRANSPORTATION

Quality Assurance and Source Inspection

Contract #: 04-0120F4Cty: SF/ALA Rte: 80 PM: 13.2/13.9File #: 69.28**WELDING INSPECTION REPORT****Resident Engineer:**Pursell, Gary**Address:** 333 Burma Road**City:** Oakland, CA 94607**Report No:** WIR-016510**Date Inspected:** 23-Aug-2010**Project Name:** SAS Superstructure**OSM Arrival Time:** 700**Prime Contractor:** American Bridge/Fluor Enterprises, a JV**OSM Departure Time:** 1900**Contractor:** Zhenhua Port Machinery Company, Ltd (ZPMC), Changxing Island **Location:** Shanghai, China

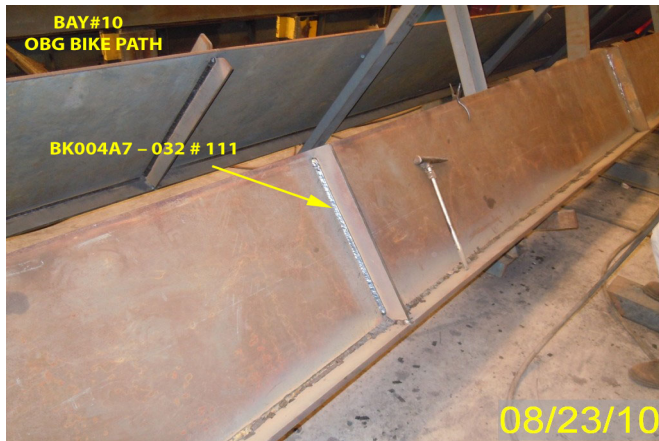
Weld joint # 111 located on Bike Path BK004A7 – 032. Welder is identified as 053870. ZPMC Quality Control (QC) Inspector is identified as Ma Qian Li. The welding variables recorded by QC appeared to comply with the WPS – B – T – 2133. (See attached photo)

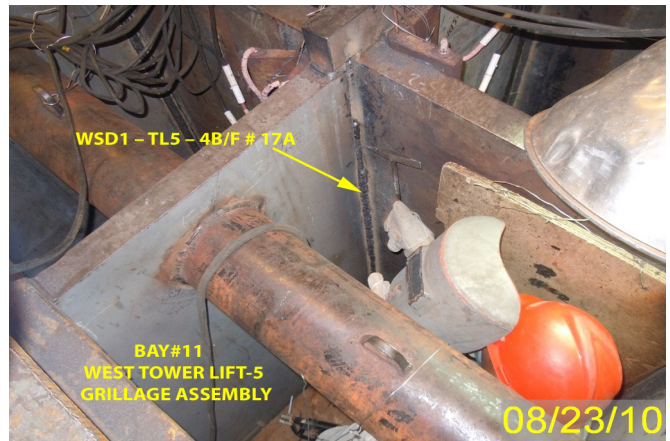
Weld joint # 17A located on West tower Lift-5 Grillage Assembly WSD1 – TL5 – 4B/F. Welder is identified as 067993. ZPMC Quality Control (QC) Inspector is identified as Zhao Mao Mao. The welding variables recorded by QC appeared to comply with the WPS – B – T – 3213 – TC – U5b.
